2019 Data Report for Fremont Lake, Newaygo County

Site ID: 620029

Fremont Lake, Newaygo County 2019 CLMP Results

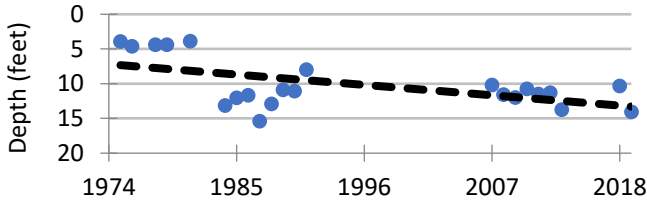
Secchi Disk Transparency (feet)

Year	# Readings	Min	Max	Average	Std. Dev	Carlson TSI
2019	8	7.5	21.5	14.1	5.4	39
2014-2018	21	5.0	18.5	14.1	4.3	43
1975-2013	319	2.0	30.0	9.9	4.1	45
2019 All CLMP Lakes	3392	1.5	50.0	12.8	5.8	42

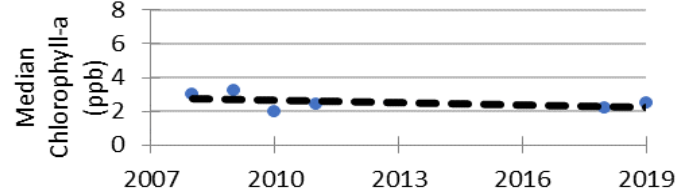
Chlorophyll-a (parts per billion)

Year	# Samples	Min	Max	Median	Std. Dev	Carlson TSI
2019	4	1.0	4.4	2.5	1.5	40
2014-2018	4	<1.0	2.5	2.2	0.9	38
2008-2013	20	<1.0	7.6	2.2	2.2	40
2019 All CLMP Lakes	635	< 1.0	42.0	2.2	3.4	39

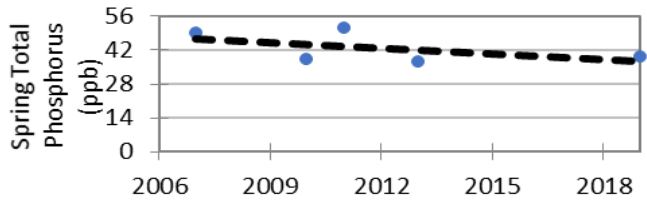
Spring Phosphorus (parts per billion)

Year	# Samples	Min	Max	Average	Std. Dev
2019	1	39.0	39.0	39.0	NA
2014-2018	4	37.0	51.0	43.8	7.3
2019 All CLMP Lakes	220	<= 3	100.0	14.9	11.0

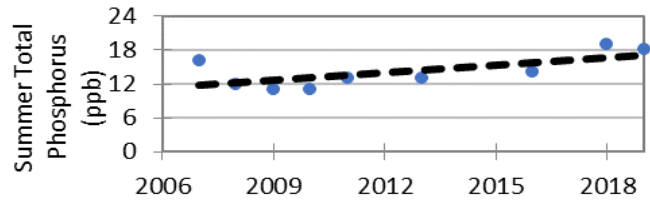
Summer Phosphorus (parts per billion)

Year	# Samples	Min	Max	Average	Std. Dev	Carlson TSI
2019	1	18.0	18.0	18.0	NA	46
2014-2018	2	14.0	19.0	16.5	3.5	44
2019 All CLMP Lakes	281	<= 3	65.0	12.8	9.3	38

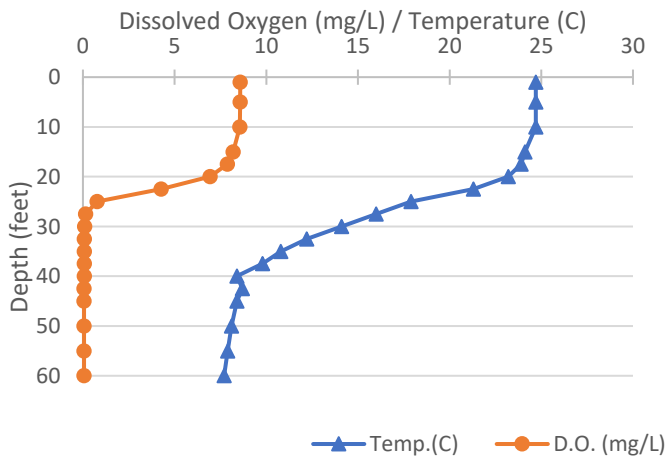
8/20/2019

Dissolved Oxygen and Temperature Profile

The lake keeps some dissolved oxygen in the bottom waters through early summer, but by early summer the lake has stratified and the bottom water is devoid of oxygen.

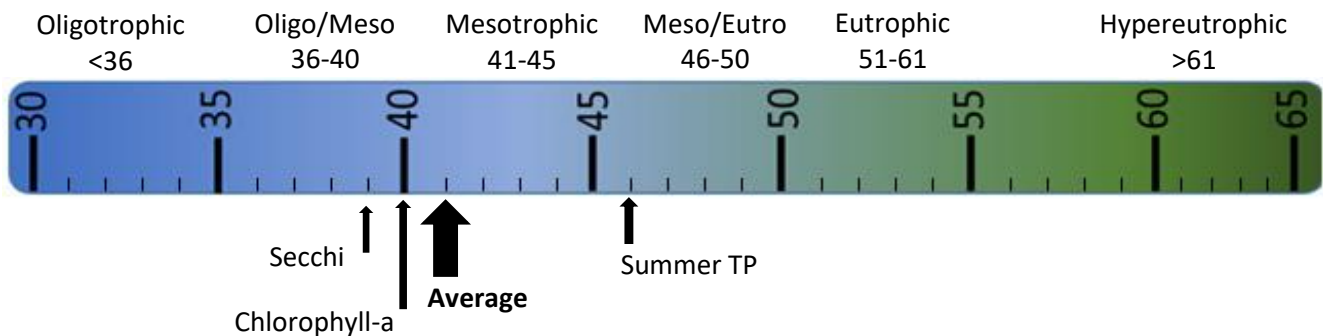
In 1977, limnologist Dr. Robert Carlson developed a numerical scale (0-100) where the numbers indicate the level of nutrient enrichment. Using the proper equations, we can convert results from Summer Total Phosphorus, Secchi Depth, and Chlorophyll-a to this Trophic Status Index (TSI). The TSI numbers are furthermore grouped into general categories (oligotrophic, mesotrophic, eutrophic, and hypereutrophic), to quickly give us a way to understand the general nutrient level of any lake.

TSI for Fremont Lake in 2019	
Average	41
Secchi Disk	39
Summer TP	46
Chlorophyll-a	40

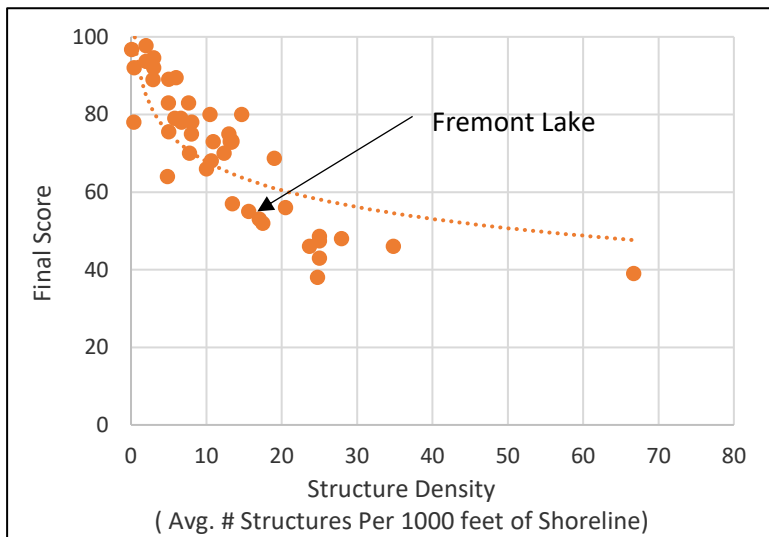
How does your lake compare to others in the program?

Fremont Lake:	
Number of Sections:	25
Number of Structures:	424
Structure Density:	17
Final Score:	53

All 42 Participating Lakes from 2015-2018:	
Avg. Number of Sections:	16.3
Avg. Number of Structures:	248.5
Avg. Structure Density:	15.2
Avg. Final Score:	70.5

Overall, the lakeshore habitat of Fremont Lake is below average when compared to the other lakes in the program. 50% percent of the lake sections score poor or worse (1 highly impacted, 12 poor, 5 fair, 7 good).

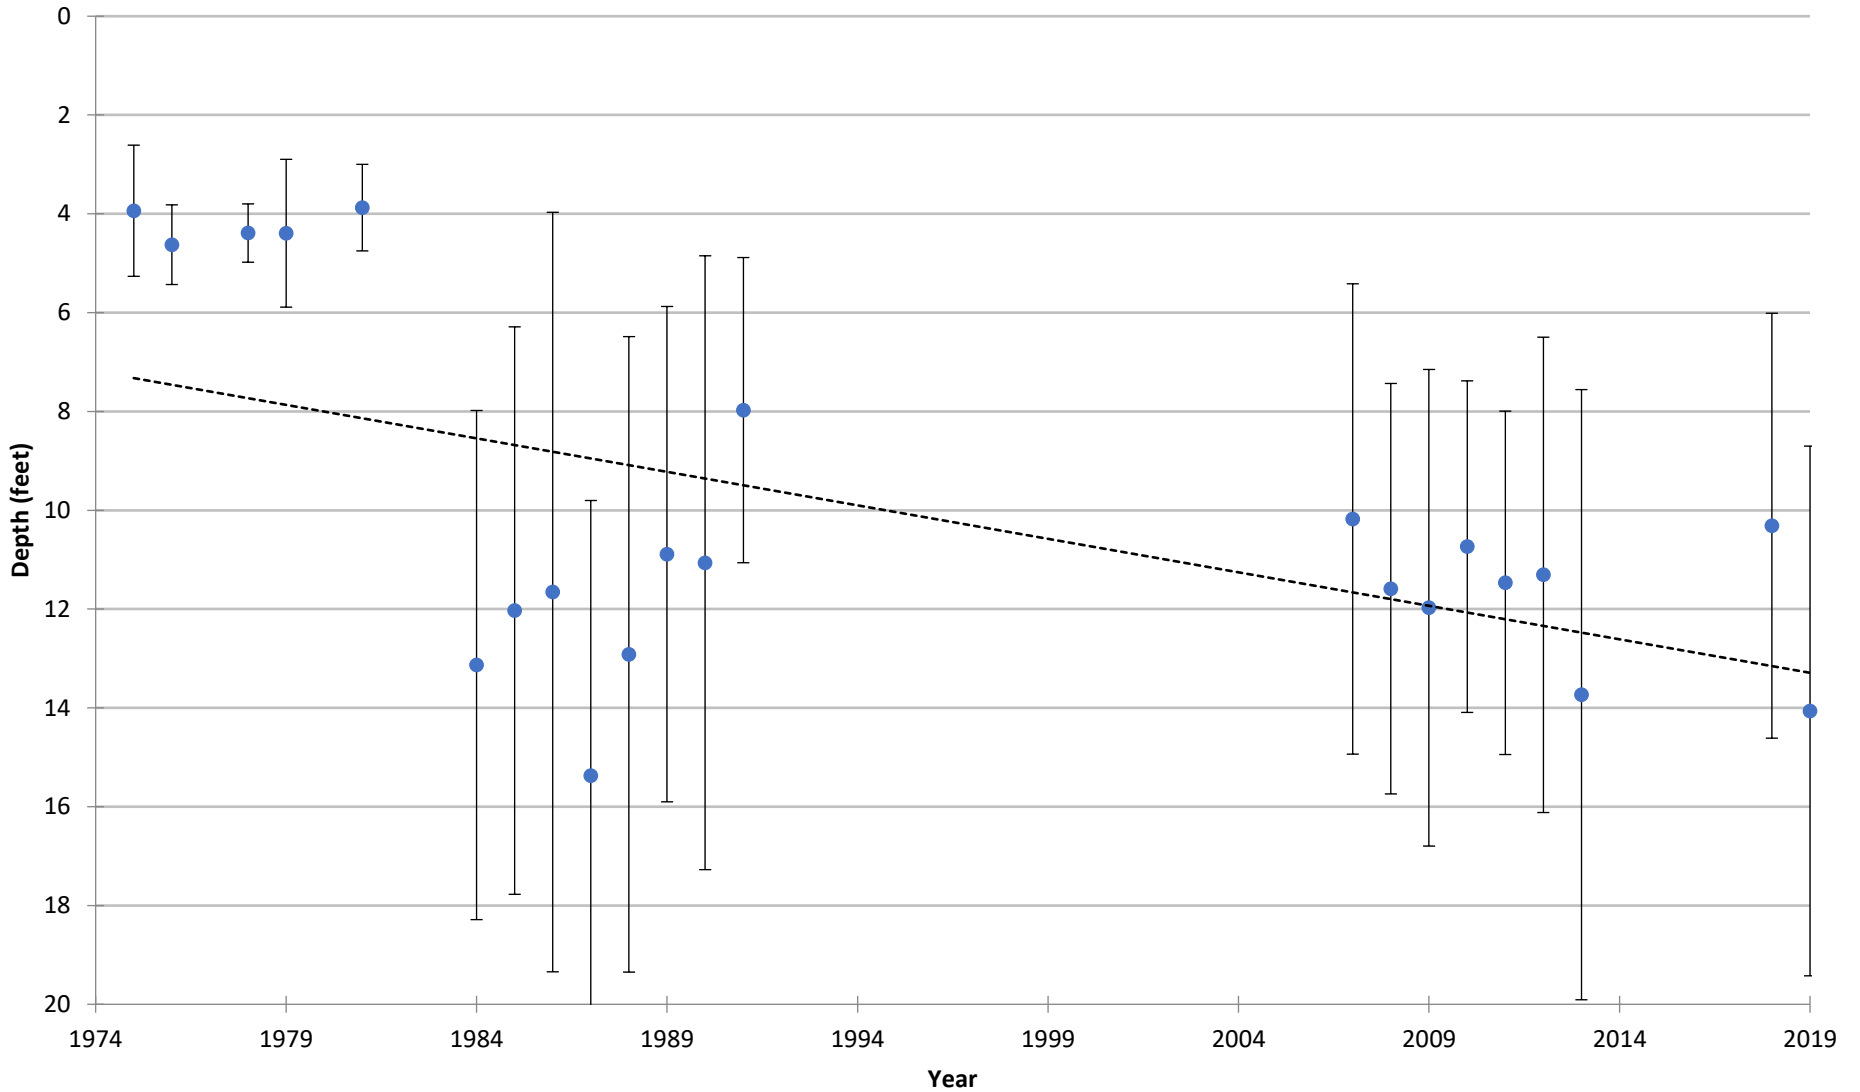
Fremont Lake (Newaygo Co.), 620029

COOPERATIVE LAKES MONITORING PROGRAM
SUMMER MEAN TRANSPARENCY

Vertical bars indicate standard deviation

While the trends for individual parameters are mixed and transparency has increased significantly, the overall nutrient levels in the lake are largely unchanged since monitoring began.

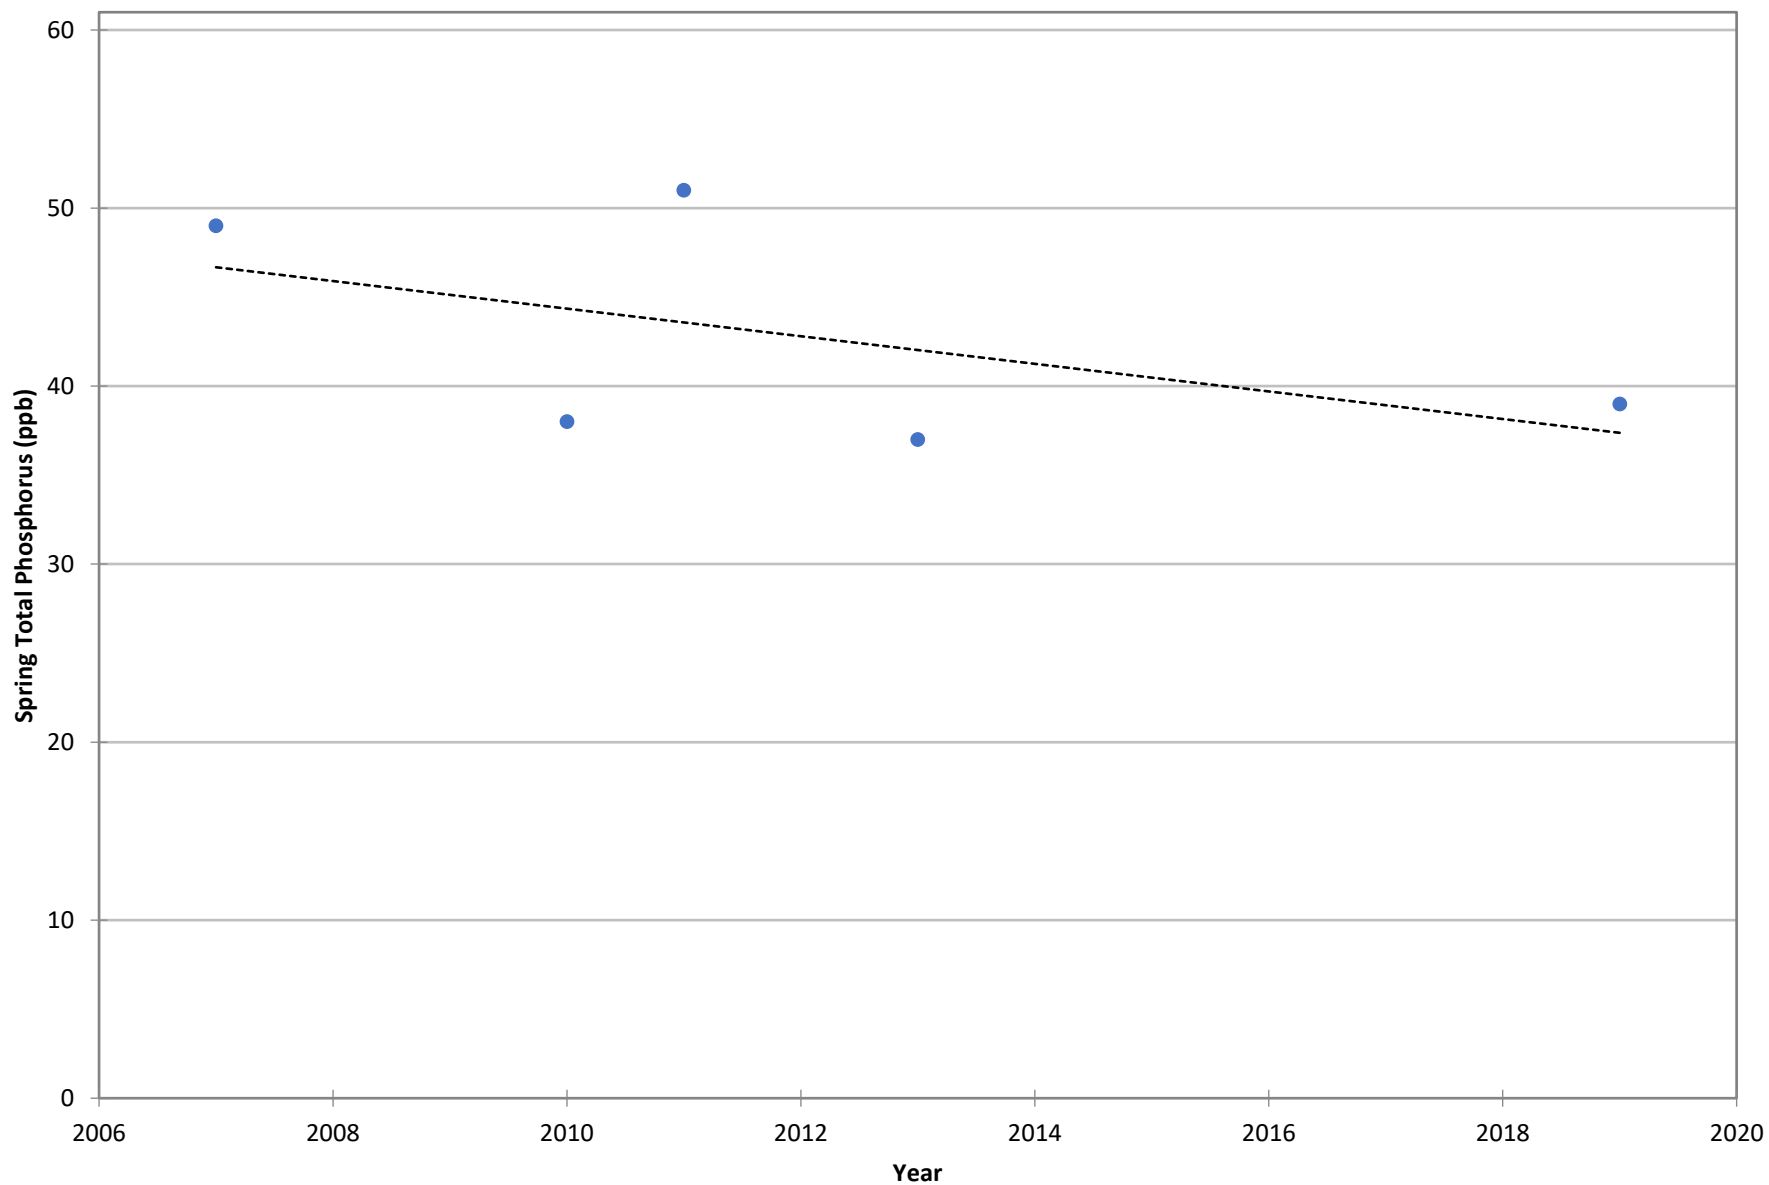
Fremont Lake (Newaygo Co.), 620029

COOPERATIVE LAKES MONITORING PROGRAM
SPRING TOTAL PHOSPHORUS

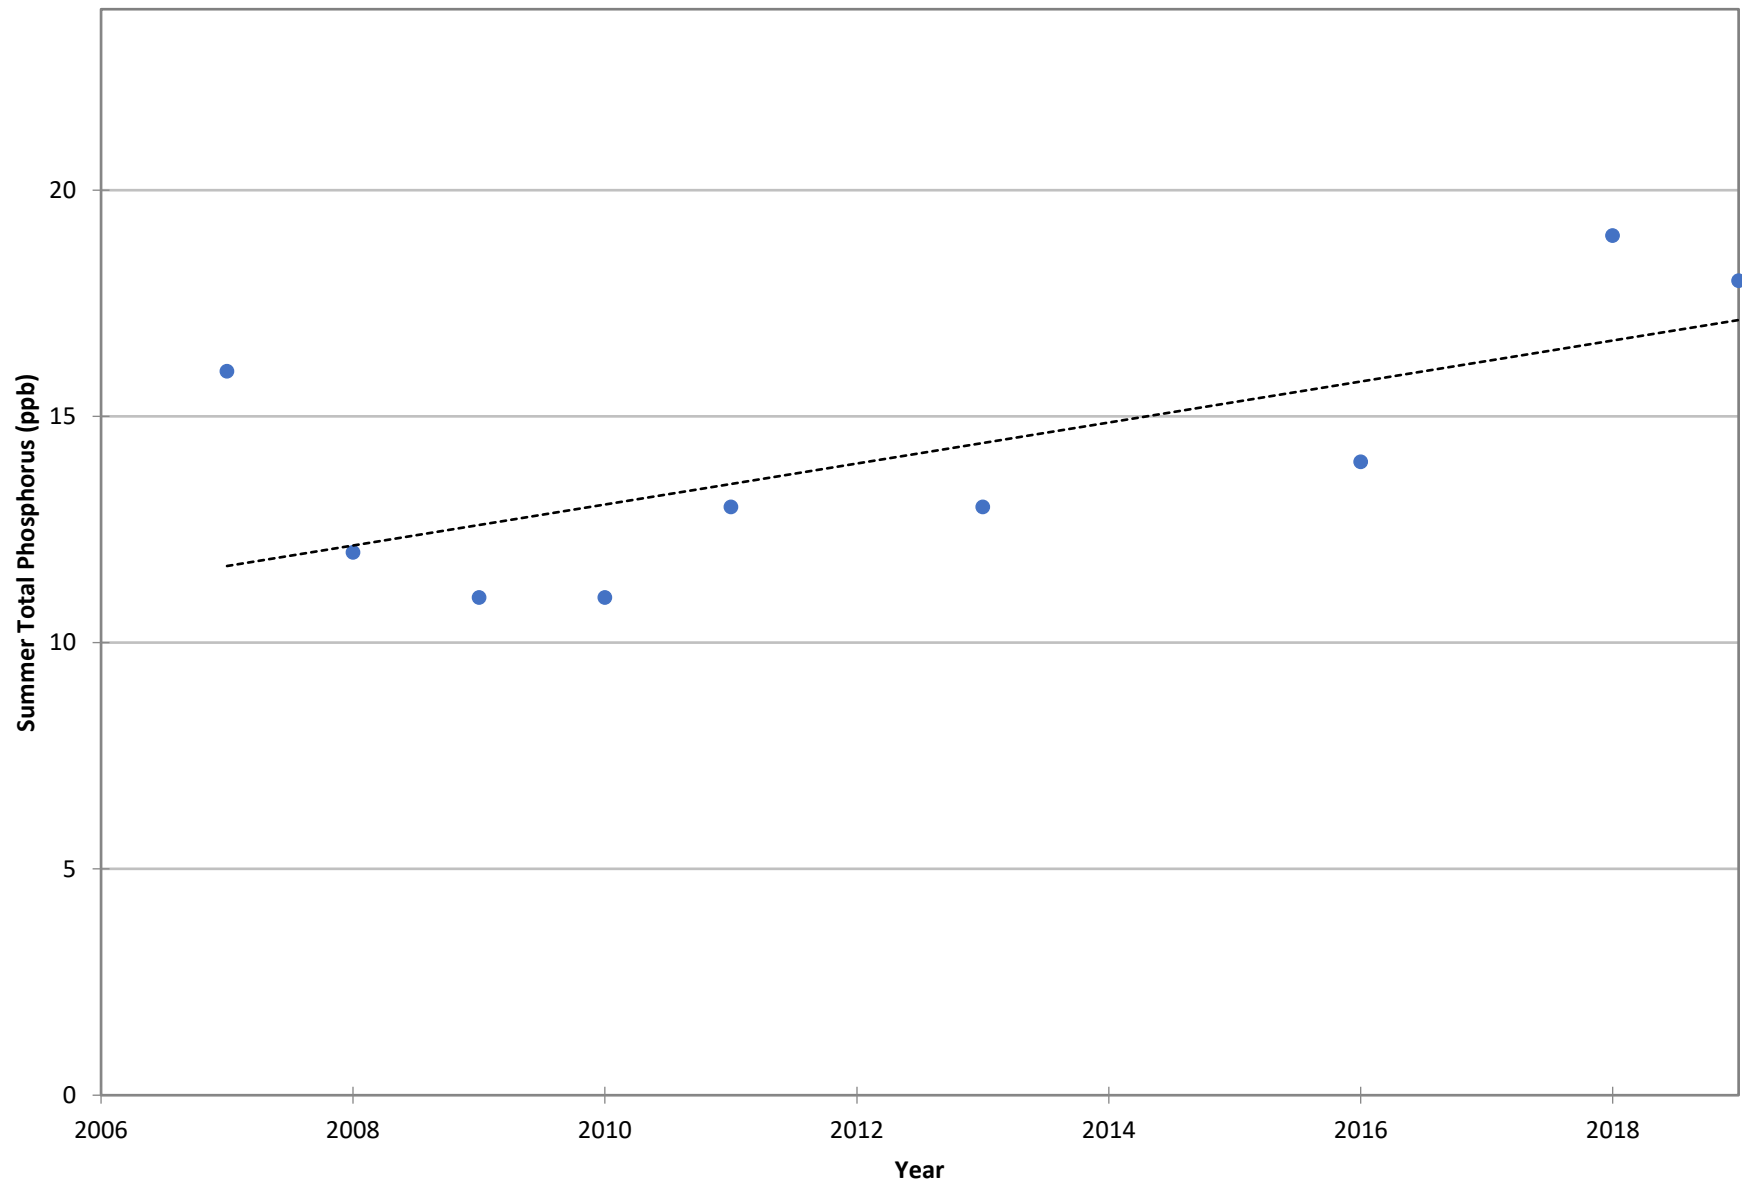
Fremont Lake (Newaygo Co.), 620029

COOPERATIVE LAKES MONITORING PROGRAM
SUMMER TOTAL PHOSPHORUS

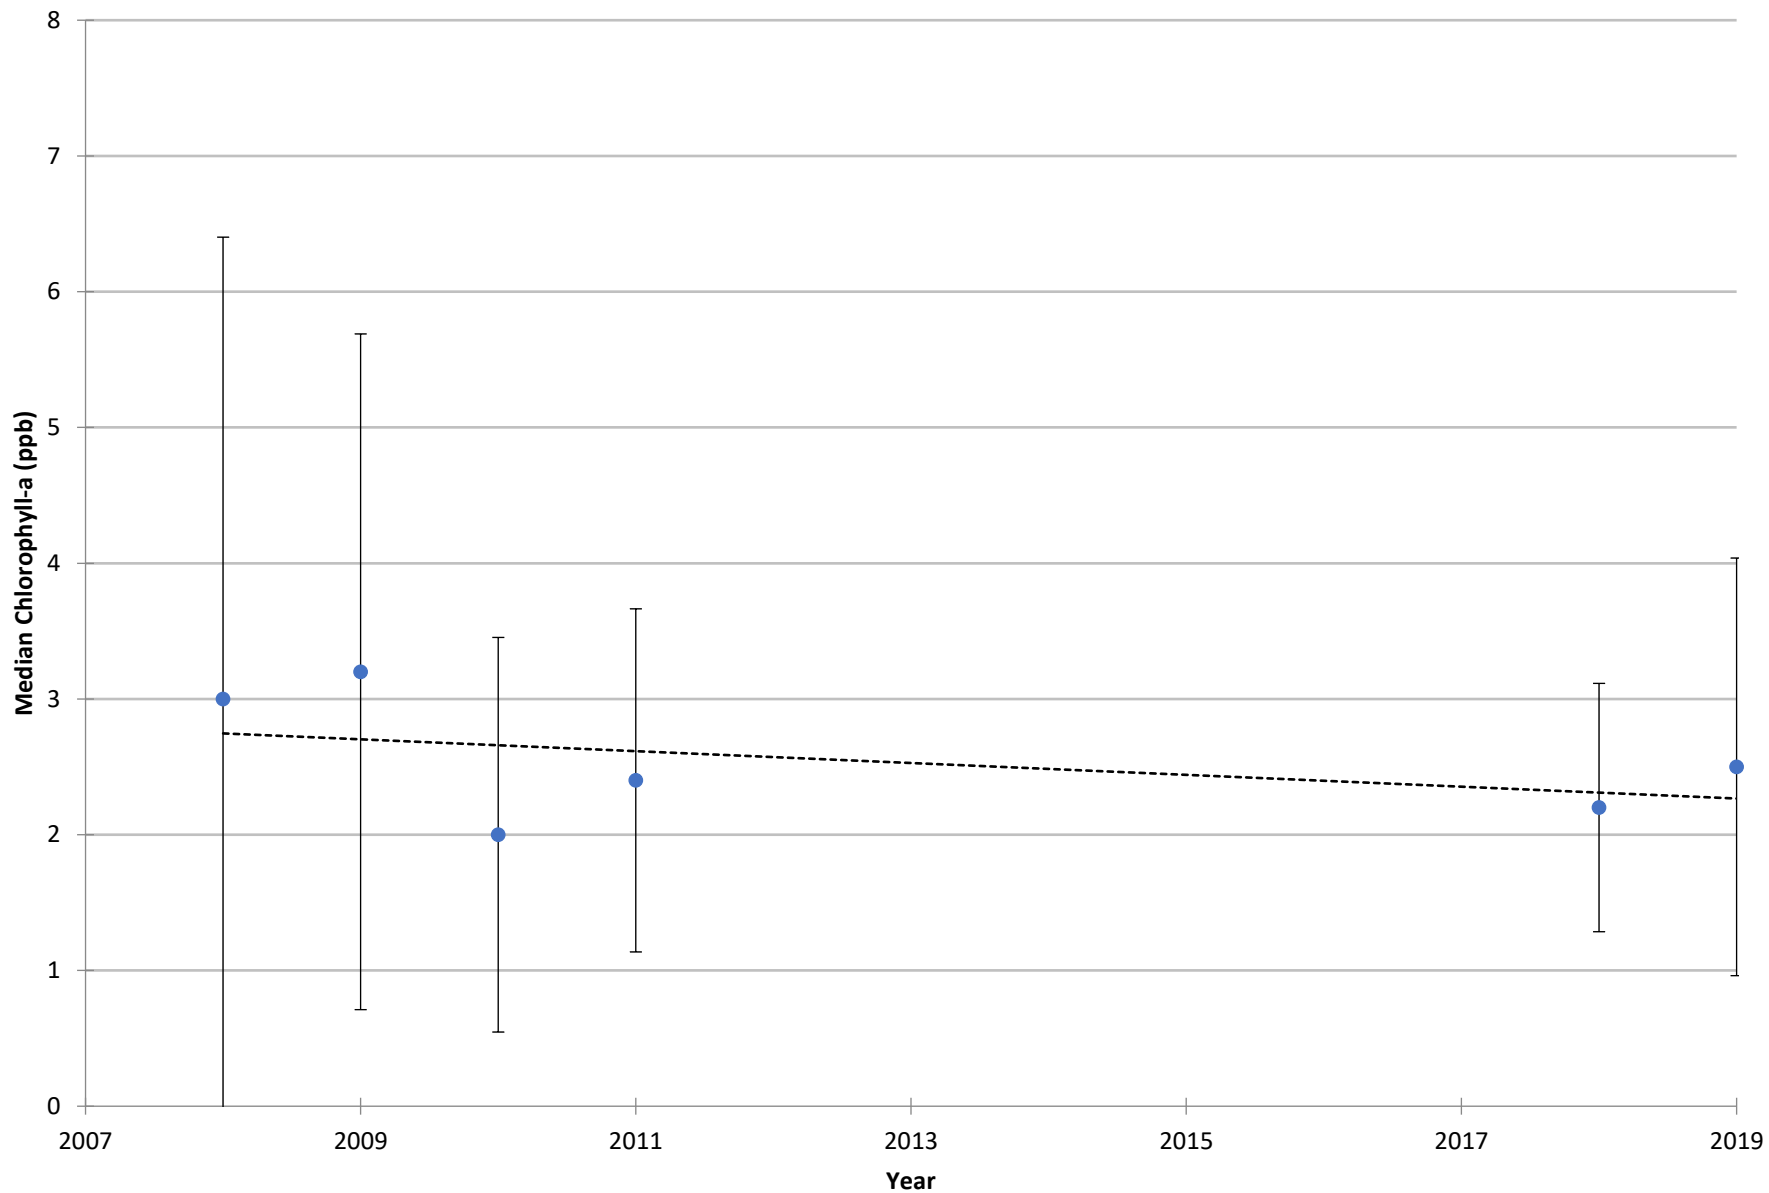
Fremont Lake (Newaygo Co.), 620029

COOPERATIVE LAKES MONITORING PROGRAM
SUMMER MEDIAN CHLOROPHYLL-A

Vertical bars indicate standard deviation

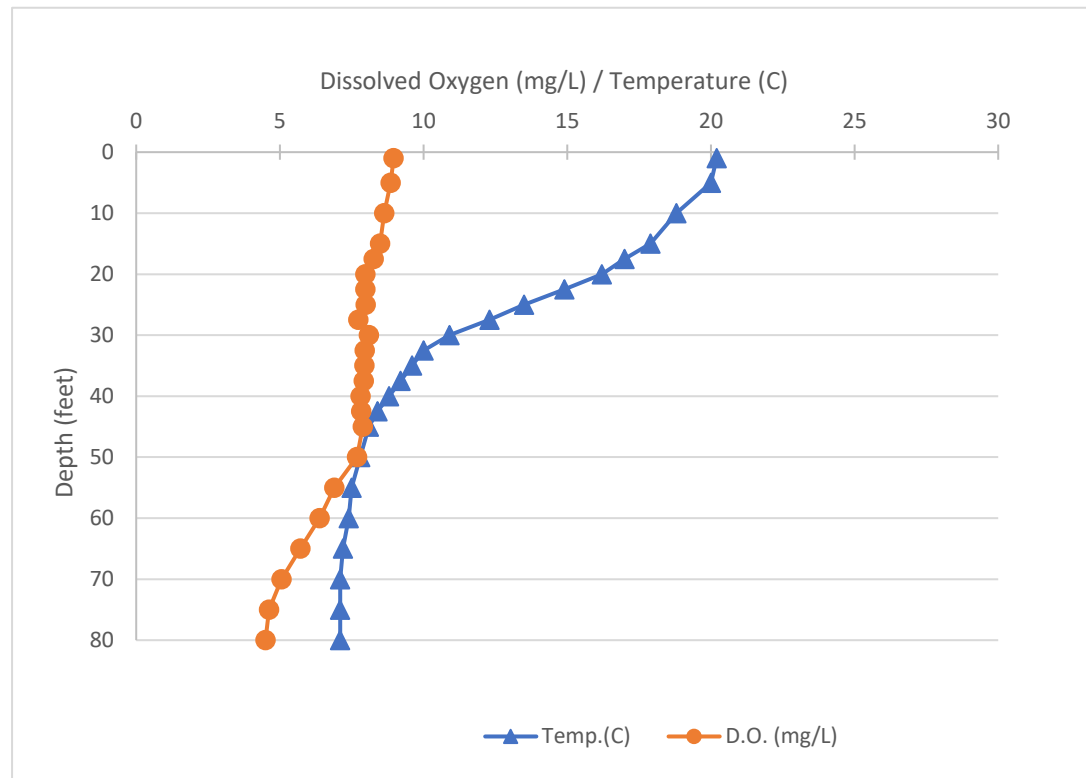
6/7/2019

Dissolved Oxygen and Temperature Profile

Depth (ft)	Temp.(C)	D.O. (mg/L)
1	20.2	8.96
5	20	8.85
10	18.8	8.63
15	17.9	8.49
17.5	17	8.27
20	16.2	7.97
22.5	14.9	7.98
25	13.5	7.99
27.5	12.3	7.73
30	10.9	8.1
32.5	10	7.95
35	9.6	7.94
37.5	9.2	7.92
40	8.8	7.81
42.5	8.4	7.83
45	8.1	7.89
50	7.8	7.69
55	7.5	6.9
60	7.4	6.38
65	7.2	5.71
70	7.1	5.06
75	7.1	4.62
80	7.1	4.5

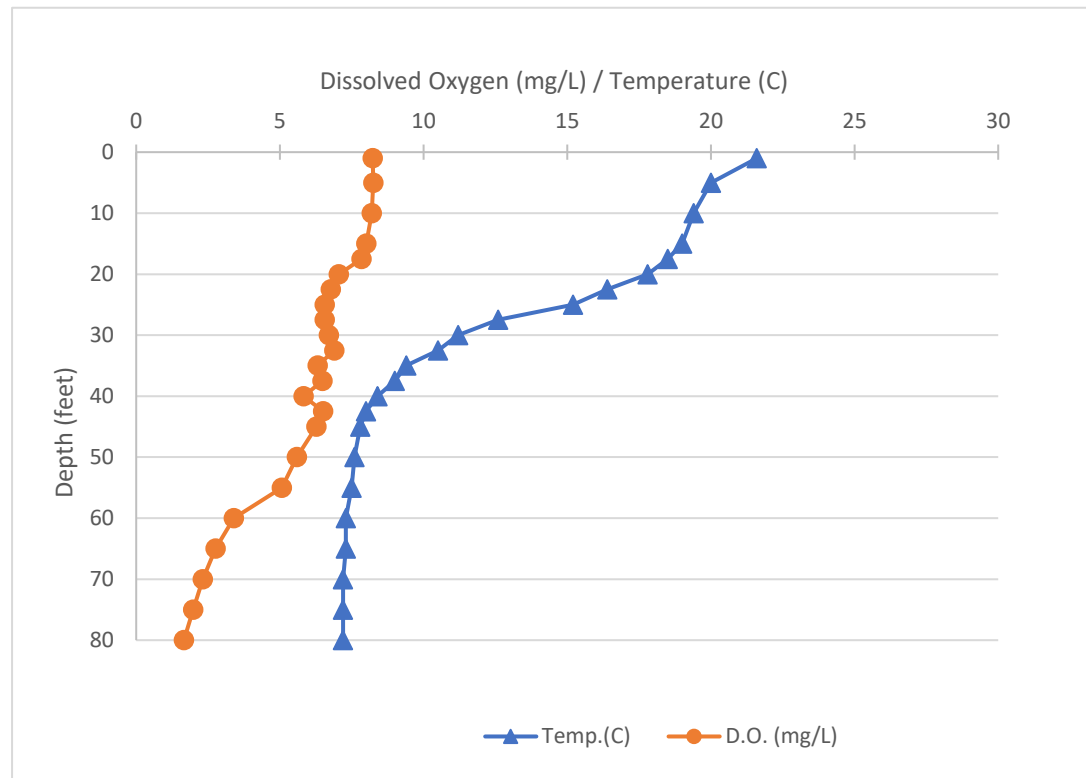
6/21/2019

Dissolved Oxygen and Temperature Profile

Depth (ft)	Temp.(C)	D.O. (mg/L)
1	21.6	8.23
5	20	8.25
10	19.4	8.2
15	19	8.01
17.5	18.5	7.84
20	17.8	7.05
22.5	16.4	6.77
25	15.2	6.56
27.5	12.6	6.56
30	11.2	6.71
32.5	10.5	6.89
35	9.4	6.32
37.5	9	6.48
40	8.4	5.83
42.5	8	6.5
45	7.8	6.27
50	7.6	5.59
55	7.5	5.07
60	7.3	3.4
65	7.3	2.76
70	7.2	2.32
75	7.2	1.98
80	7.2	1.66

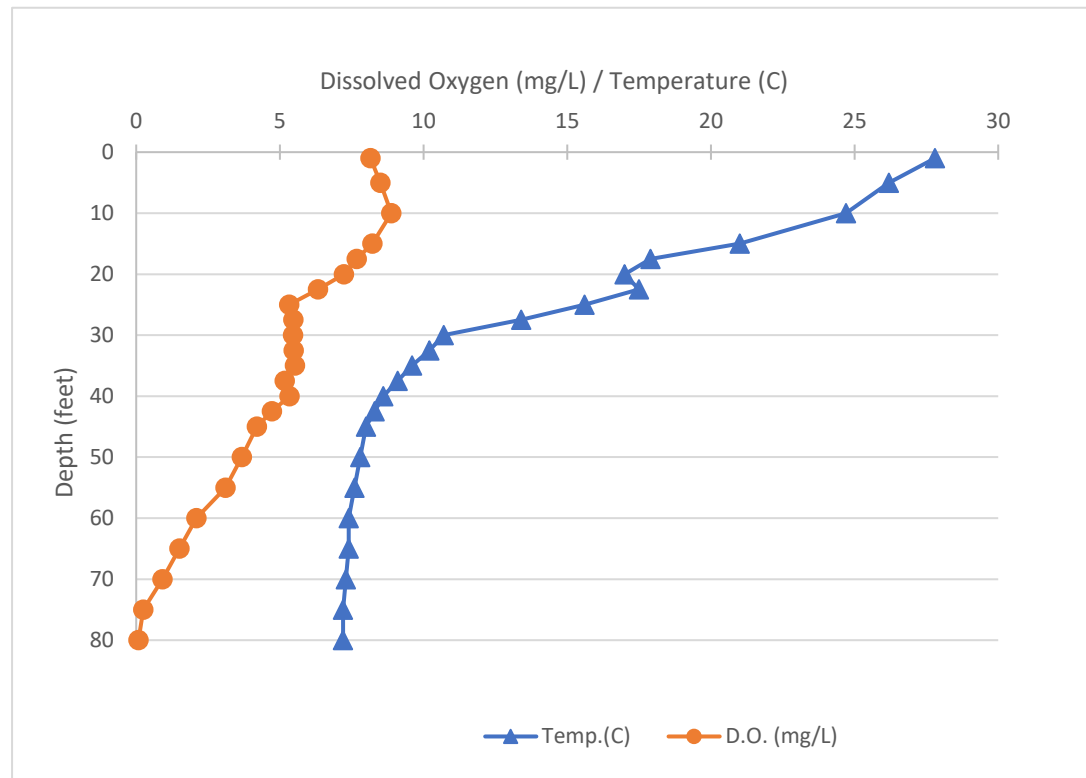
7/3/2019

Dissolved Oxygen and Temperature Profile

Depth (ft)	Temp.(C)	D.O. (mg/L)
1	27.8	8.15
5	26.2	8.5
10	24.7	8.88
15	21	8.22
17.5	17.9	7.68
20	17	7.23
22.5	17.5	6.33
25	15.6	5.32
27.5	13.4	5.47
30	10.7	5.46
32.5	10.2	5.48
35	9.6	5.52
37.5	9.1	5.17
40	8.6	5.34
42.5	8.3	4.72
45	8	4.2
50	7.8	3.68
55	7.6	3.11
60	7.4	2.09
65	7.4	1.51
70	7.3	0.92
75	7.2	0.25
80	7.2	0.08

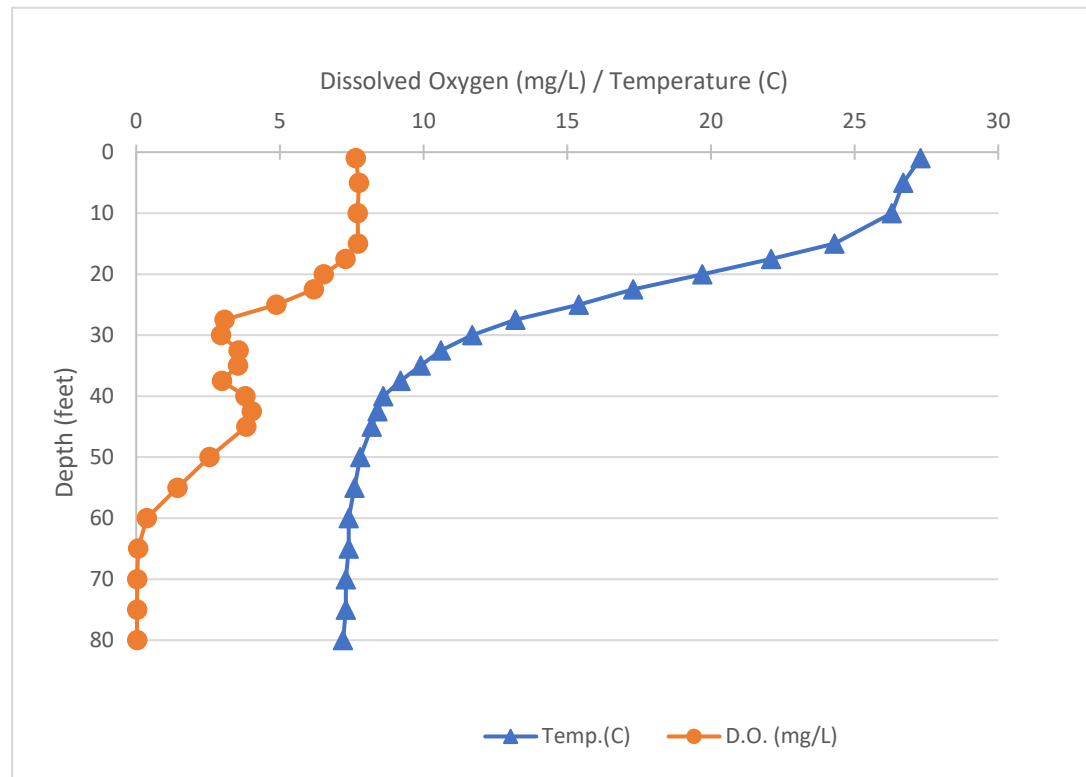
7/17/2019

Dissolved Oxygen and Temperature Profile

Depth (ft)	Temp.(C)	D.O. (mg/L)
1	27.3	7.64
5	26.7	7.75
10	26.3	7.71
15	24.3	7.72
17.5	22.1	7.28
20	19.7	6.53
22.5	17.3	6.18
25	15.4	4.88
27.5	13.2	3.07
30	11.7	2.95
32.5	10.6	3.57
35	9.9	3.54
37.5	9.2	2.99
40	8.6	3.8
42.5	8.4	4.02
45	8.2	3.83
50	7.8	2.55
55	7.6	1.44
60	7.4	0.37
65	7.4	0.07
70	7.3	0.04
75	7.3	0.03
80	7.2	0.03

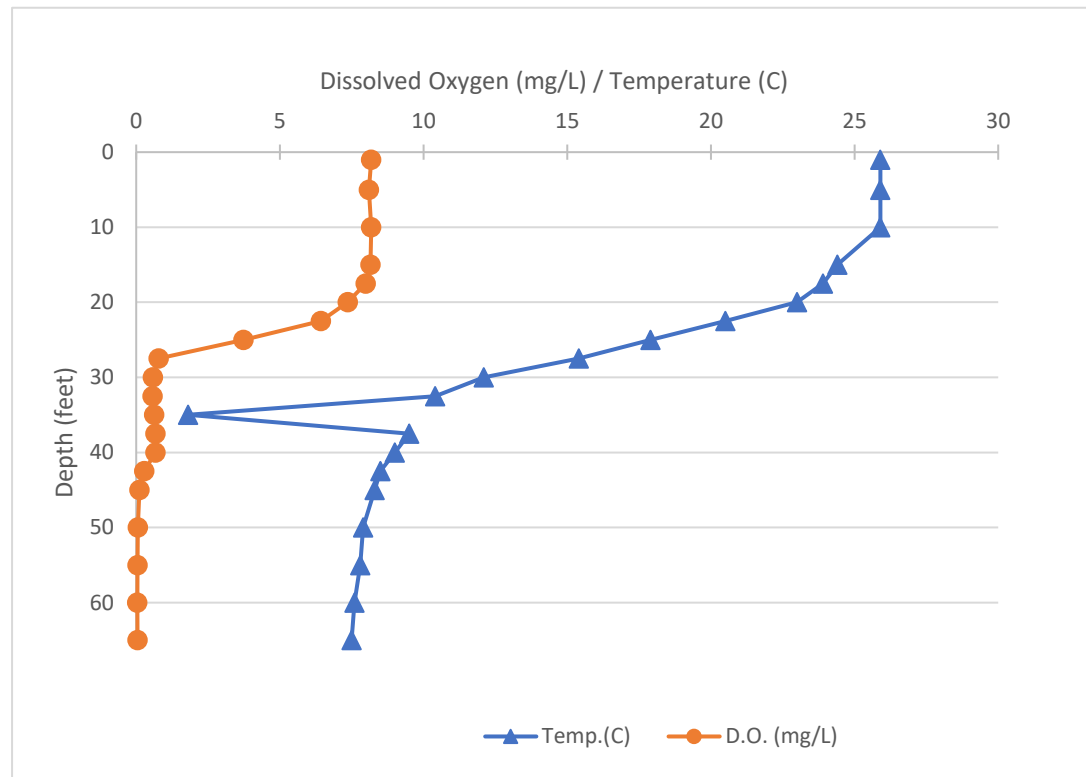
8/8/2019

Dissolved Oxygen and Temperature Profile

Depth (ft)	Temp.(C)	D.O. (mg/L)
1	25.9	8.18
5	25.9	8.1
10	25.9	8.18
15	24.4	8.15
17.5	23.9	7.99
20	23	7.36
22.5	20.5	6.43
25	17.9	3.73
27.5	15.4	0.78
30	12.1	0.58
32.5	10.4	0.57
35	1.8	0.63
37.5	9.5	0.67
40	9	0.67
42.5	8.5	0.28
45	8.3	0.11
50	7.9	0.06
55	7.8	0.05
60	7.6	0.04
65	7.5	0.05

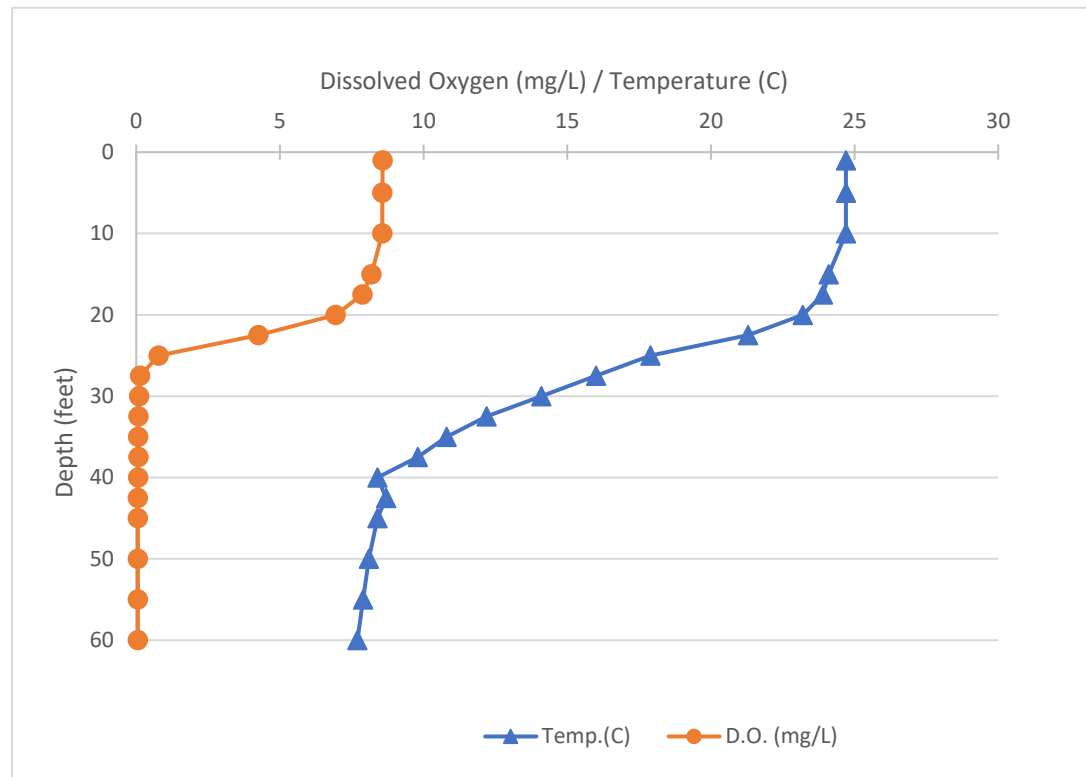
8/20/2019

Dissolved Oxygen and Temperature Profile

Depth (ft)	Temp.(C)	D.O. (mg/L)
1	24.7	8.58
5	24.7	8.57
10	24.7	8.56
15	24.1	8.19
17.5	23.9	7.87
20	23.2	6.94
22.5	21.3	4.26
25	17.9	0.78
27.5	16	0.14
30	14.1	0.1
32.5	12.2	0.08
35	10.8	0.07
37.5	9.8	0.08
40	8.4	0.07
42.5	8.7	0.06
45	8.4	0.06
50	8.1	0.06
55	7.9	0.06
60	7.7	0.06

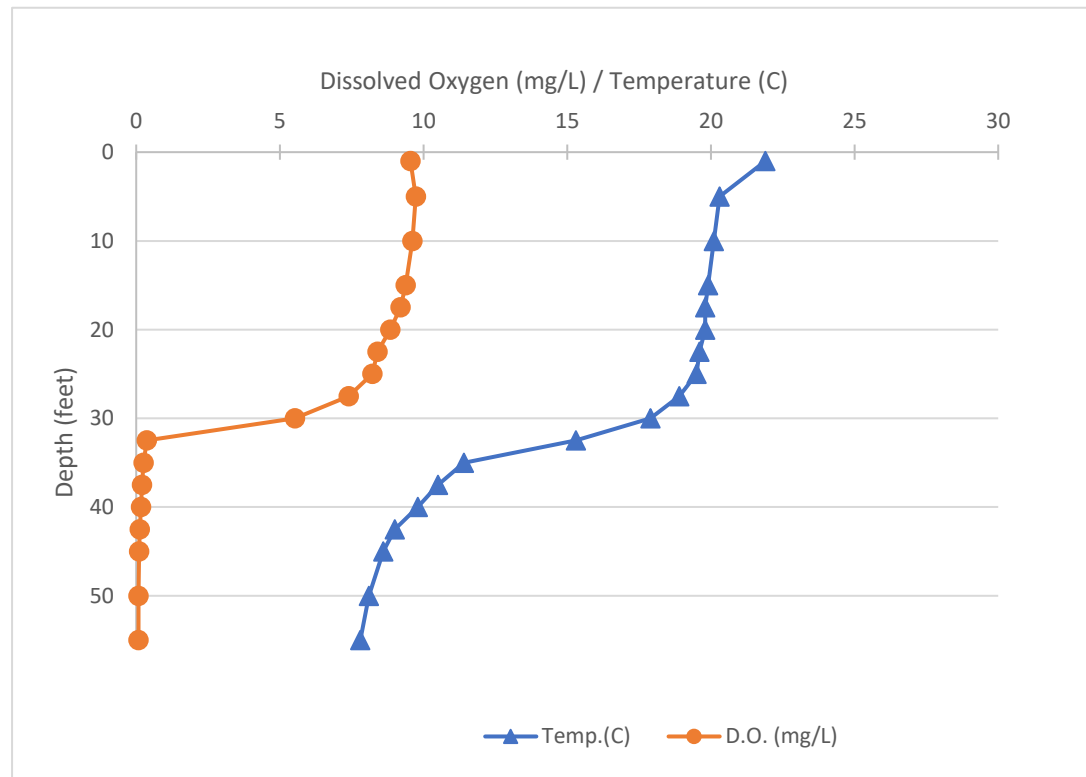
9/16/2019

Dissolved Oxygen and Temperature Profile

Depth (ft)	Temp.(C)	D.O. (mg/L)
1	21.9	9.54
5	20.3	9.73
10	20.1	9.61
15	19.9	9.38
17.5	19.8	9.2
20	19.8	8.84
22.5	19.6	8.4
25	19.5	8.22
27.5	18.9	7.4
30	17.9	5.53
32.5	15.3	0.37
35	11.4	0.26
37.5	10.5	0.2
40	9.8	0.17
42.5	9	0.12
45	8.6	0.1
50	8.1	0.08
55	7.8	0.08
